# Safety Incident

Portland Park Embankment – LNE Aug 2017

PBS1 2100 137m 70ch

# Level 1: Preliminary Findings

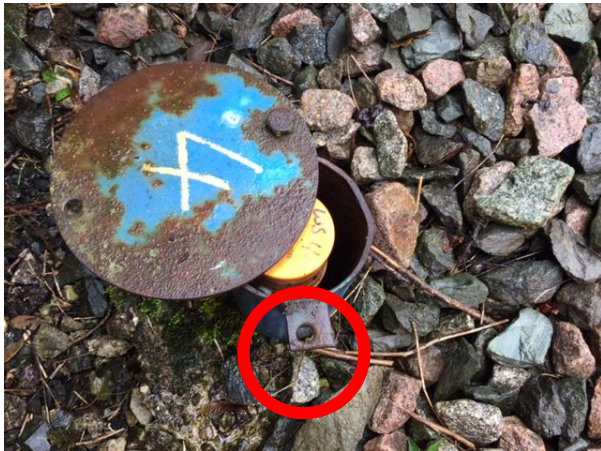
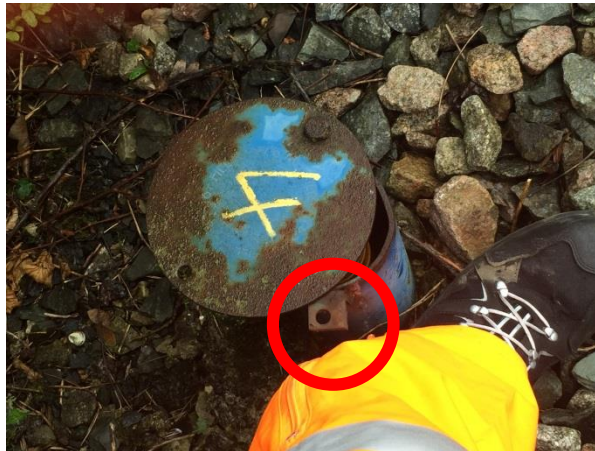
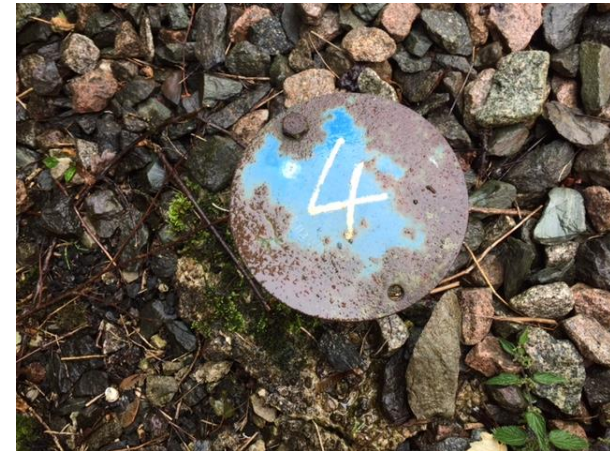
- Incident occurred at approximately 00:20 on Sunday 8<sup>th</sup> August 2017 during a possession. Underfoot conditions were wet during falling rain. Visibility less than 200 yards and lighting was by Head Lamp and Hand Torch.
- Member of staff was placing protection and turned to change direction. This action caused him to lose balance, tripping over the cess rail and stumbling down the upper part of the embankment approximately three to four yards.
- The member of staff made an abrupt contact with part of the steel protection cover (from an earthworks monitoring instrument). This caused a laceration to the top of his left ankle just above the boot line. Operative taken to A&E where morphine was administered and the laceration required 11 stitches. Hospital advised of 10 days rest.

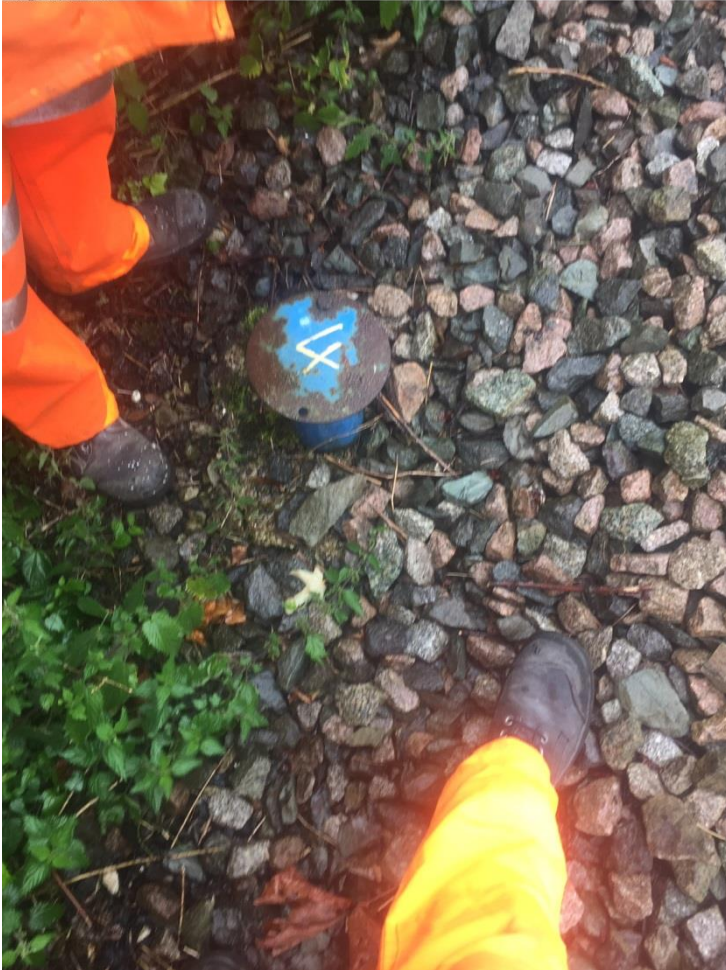
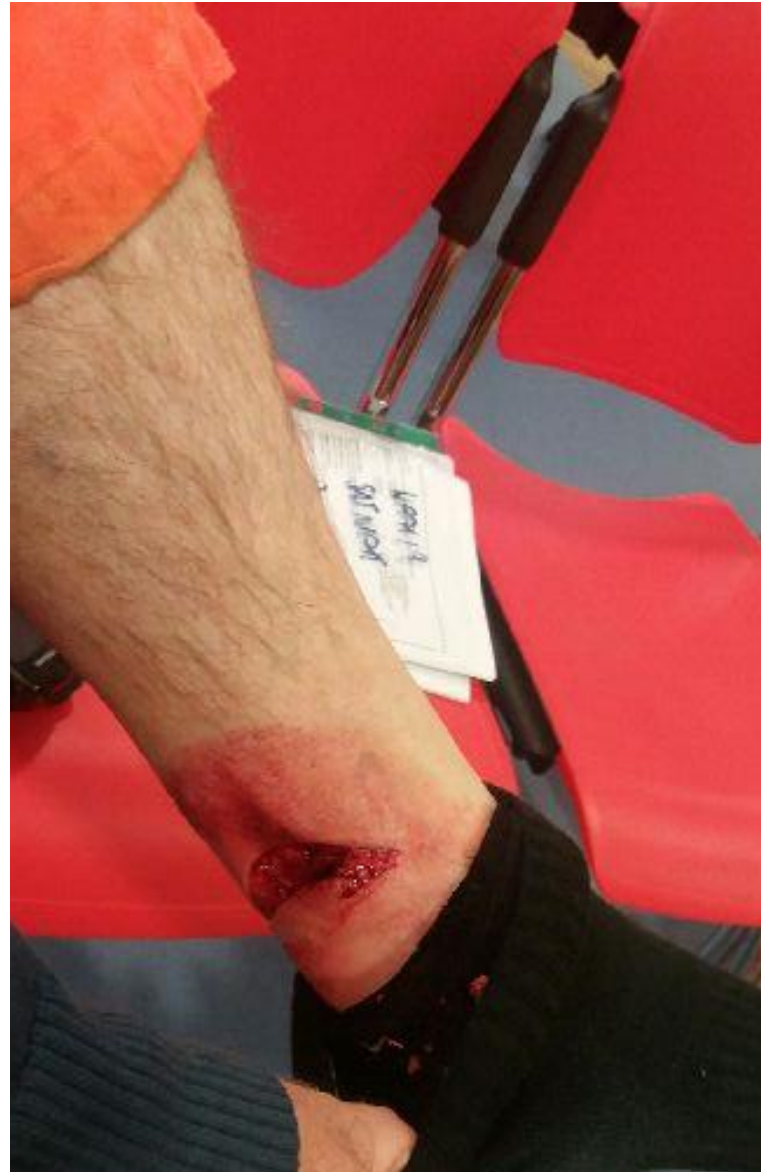
# Sustained Laceration

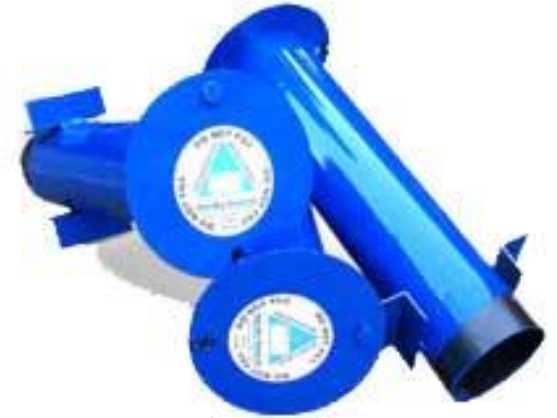
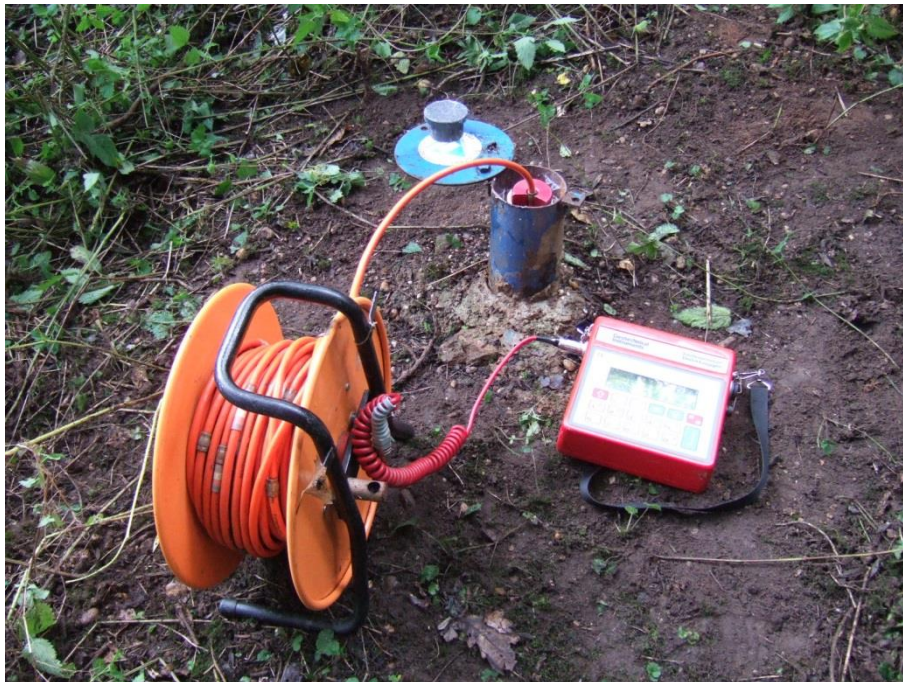
- Borehole covers installed to protect monitoring hole
- Locations are monitored predominately by manual reading of inclinometer torpedo and data logger (see below)
- Made from steel the top cover plate is held by a welded pin and allows rotation through 360-degrees
- Cover is lockable by using a padlock

- Do RAM Geotech teams have clear monitoring plans that detail how these locations should be left after readings have taken place?
- Should all covers be secured (noting that padlocks often rust shut) to prevent exposure to the locking square in slide 2?

- Should modifications be made to the standard detail?
- What should be done where the top cover plate cannot be closed (i.e. a protruding tube?)
