AGS 12 September 2018

Ground Gas Risk – The Risk from Incorrect Characterisation

Gavin Allsopp
Principal Geo-Environmental Engineer
National House Building Council

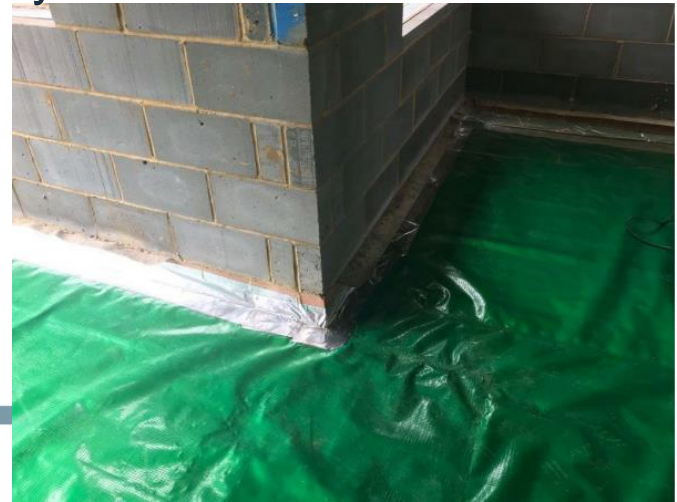
- Install gas membrane but construction started?
- Solutions – Monitor from sub floor void or retro fit gas membrane?
- Builder chose retro fit membrane & further RA.
- Could not easily be installed across the cavity
- So retro fit to the floor slab and lapped the membrane up the wall and tie into DPC
- Self adhesive also applied at wall junction
- Risk Assessment for ingress via cavity

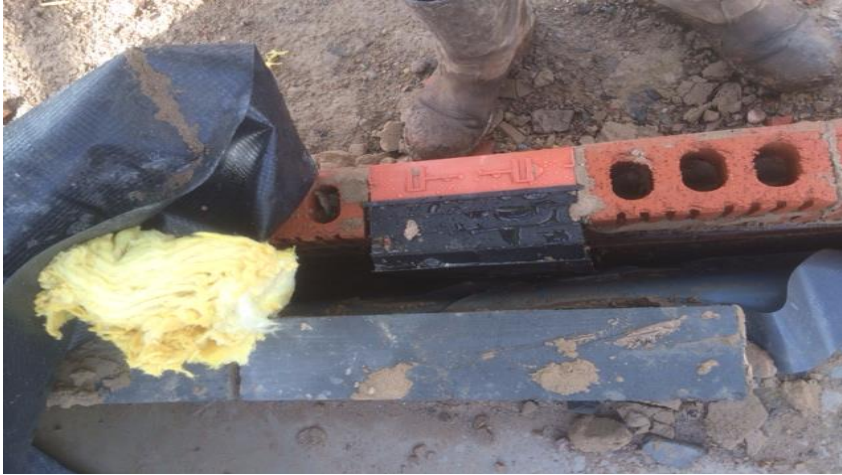
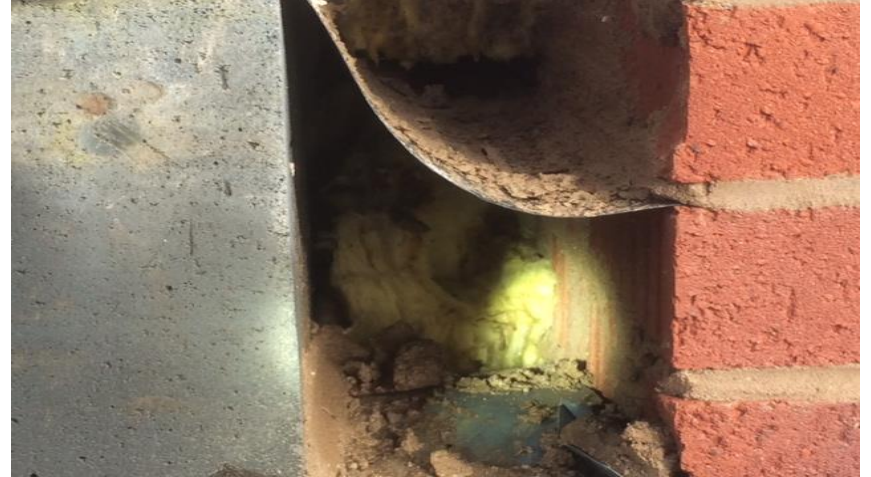
Case Study 2 - Photos

- Gas measures installed but membrane cut off at cavity and not sealed around door thresholds. Membrane not lapped with cavity tray – ingress risk to cavity & to habitable spaces.
- Terraced properties, only ventilated at front & rear, 1 vent brick front and back (level access limited inclusion of crank vents). Unable to achieve 1 air change per 24hr as per NHBC Report 04 (March 2007).

- Post construction in well & subfloor monitoring with Gasclam & spot monitoring found CH₄ 41.8%, CO₂ 21.5% with flow rates of 6.6l/hr in the wells, CH₄ recorded 0.15% in the subfloor! Reassessed as CS3/Amber 2.
- Remedial mitigation required to remedy deficiencies in gas measures.
- As plots already constructed and 2000g membrane installed, only option was to increase ventilation and limit gas ingress rate to cavity.

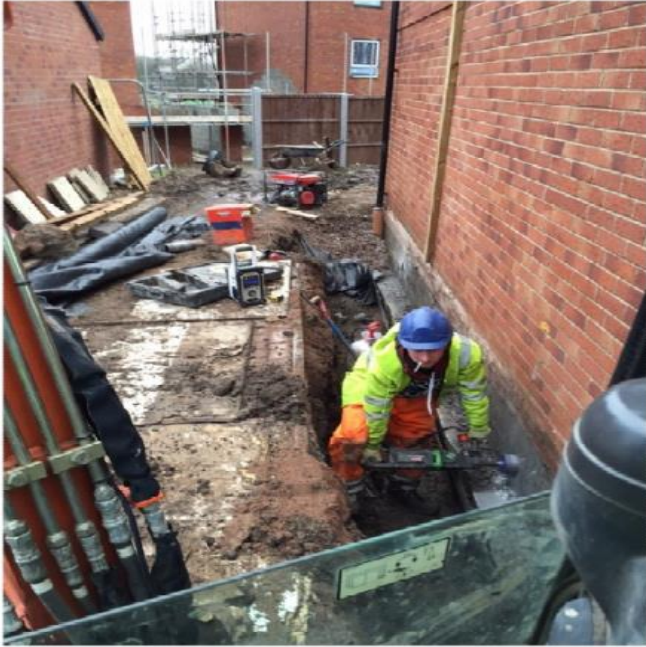
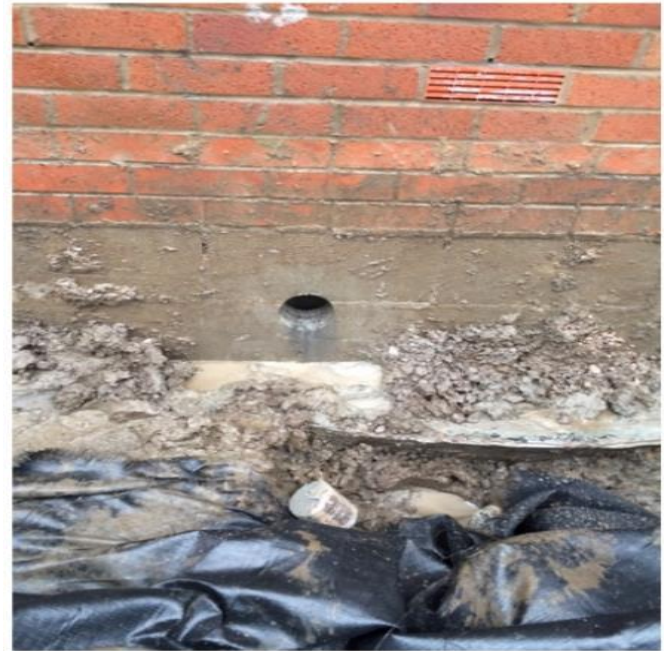
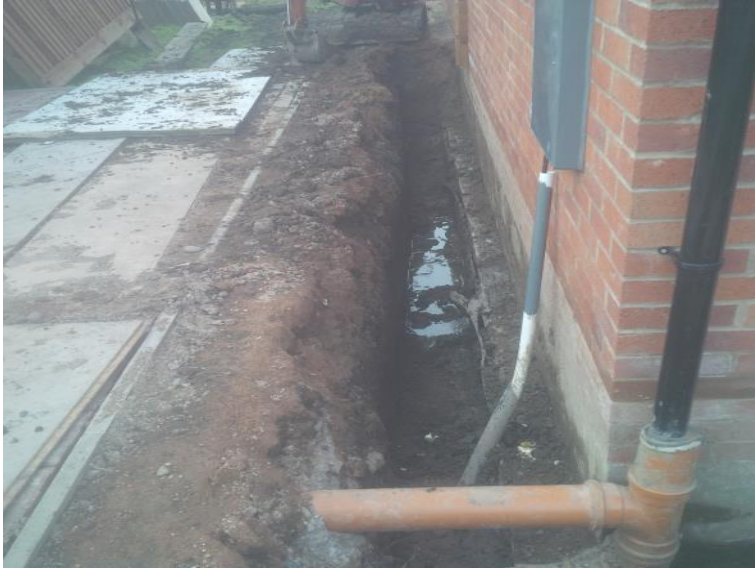
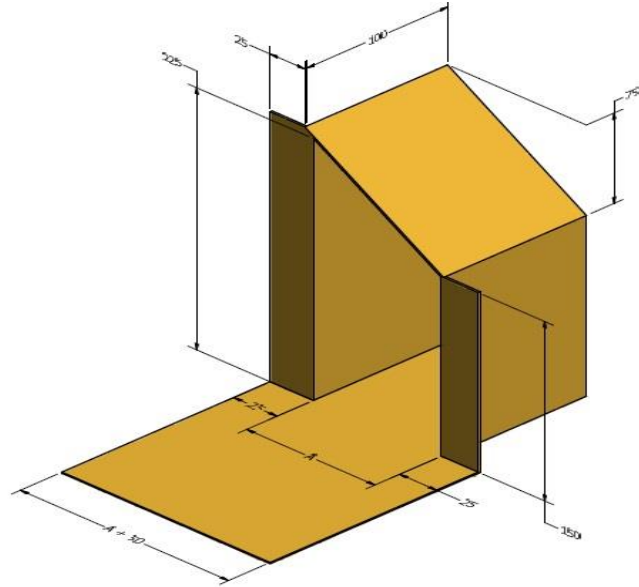
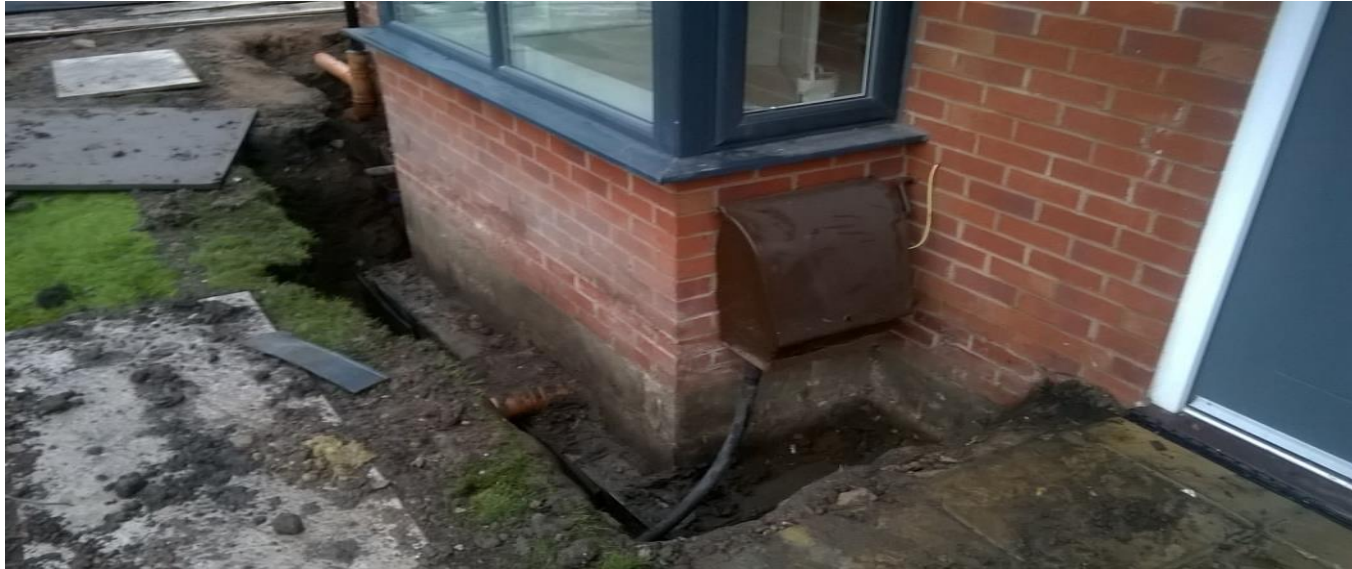
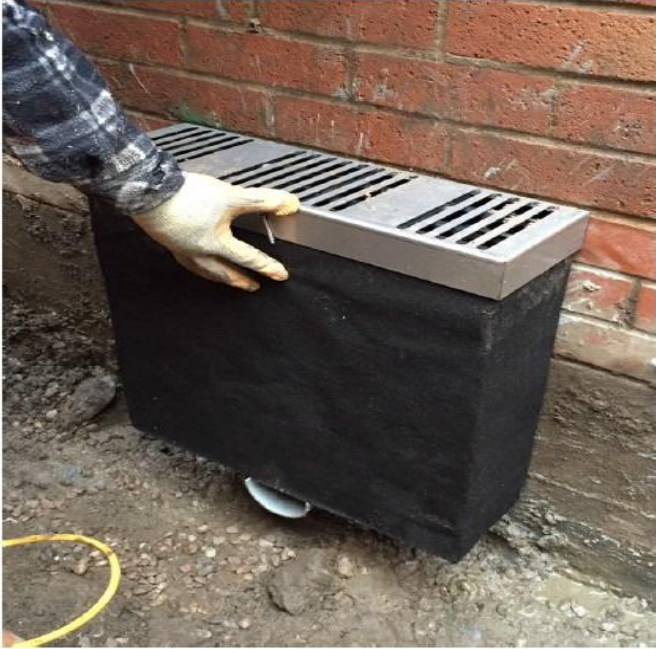
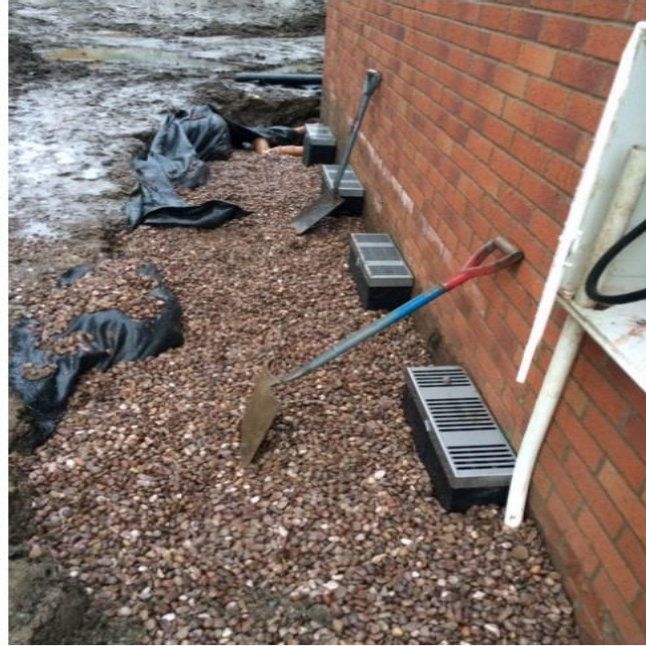
- Resulted in substantial remedial works being required.
- Cost the builder a lot of money and time.
- Delays in the release of our warranties – our warranties were not released until the remedial measures had been completed and verified.

- Excavate trench around perimeter
- Drill through to subfloor
- External vent boxes
- Preformed cavity closers at door thresholds
- Foam fill cavity below tray.
